ALERT SERVICE BULLETIN

ISSOIRE AVIATION No.

CONCERNED AIRCRAFT: APM20, APM30, APM40 & APM41

SUBJECT: Inspection and change of flap lever screws

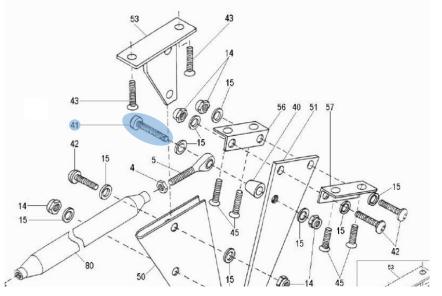
Due to a wrong assembly, the flap lever screws may be subjected to unusual loads that introduces a potentially unsafe condition.

Part number	Description
E27161 060 050 QVLE	VIS CHC 6 X 50 (2 per aircraft)

Part is visible on following exploded view extracted from IPC (#41):

- Unscrew the lock nut #14.
- Unscrew the screw #41.
- Keep the two (2) washer #15 and spacer #40.

• Screw the new screw #41 in the flap lever #51 through the washer #15, the ball joint #5 and the spacer #40.

- Tighten the screw to 10 N.m with a torque wrench.
- Install and tighten the lock nut #14 and the washer #15 on the other side of the flap lever #51.

DANGER: Tightening of the screw #41 must be carried out by the screw head and with a torque wrench to a torque of 10 N.m (class 8.8, see tightening table in the maintenance manual). The low lock nut #14 (ref: E27421HM 060 BCL) must be approached and then tightened by holding the screw head in place with a wrench. Take care that the tightened stacking does not present any free play.
